# WOWMAP

Watch Our Water -  
Maharakeke And Porangahau

# Maharakeke and Porangahau Catchment

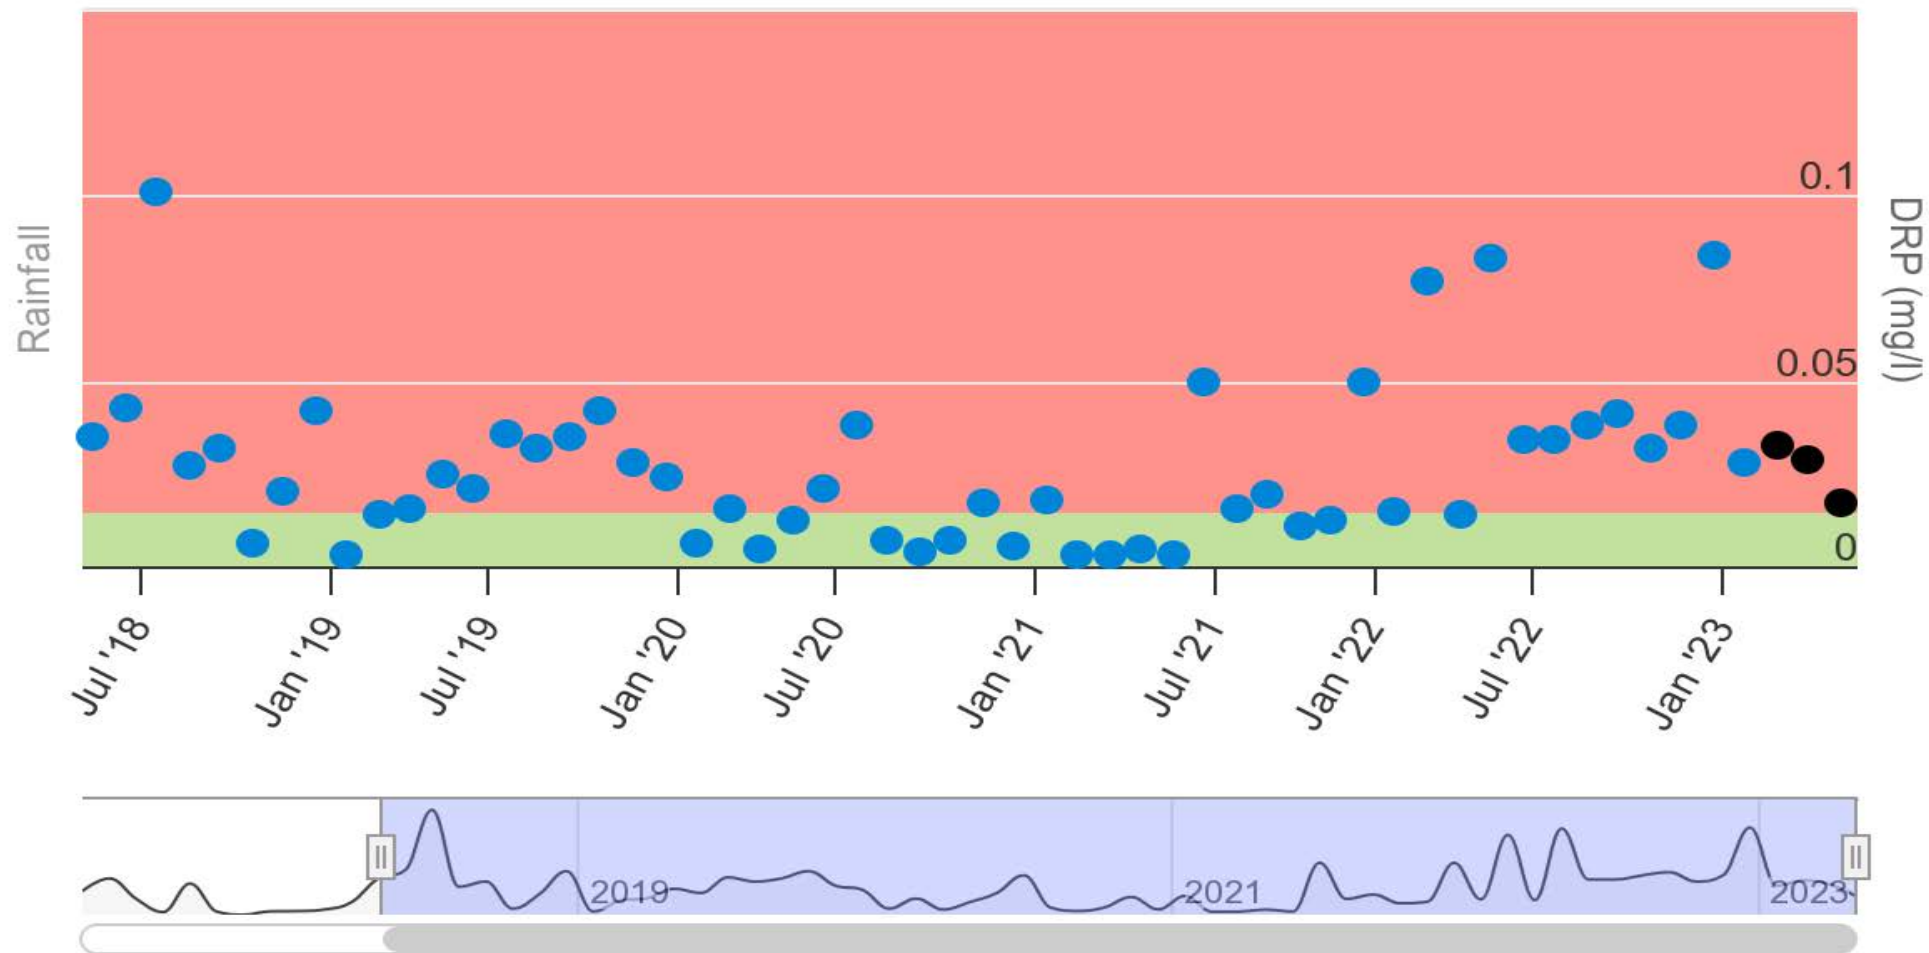
# Phosphorous (DRP) for Porangahau Strm US Maharakeke Strm

● Porangahau Strm US Maharakeke Strm ● Rainfall

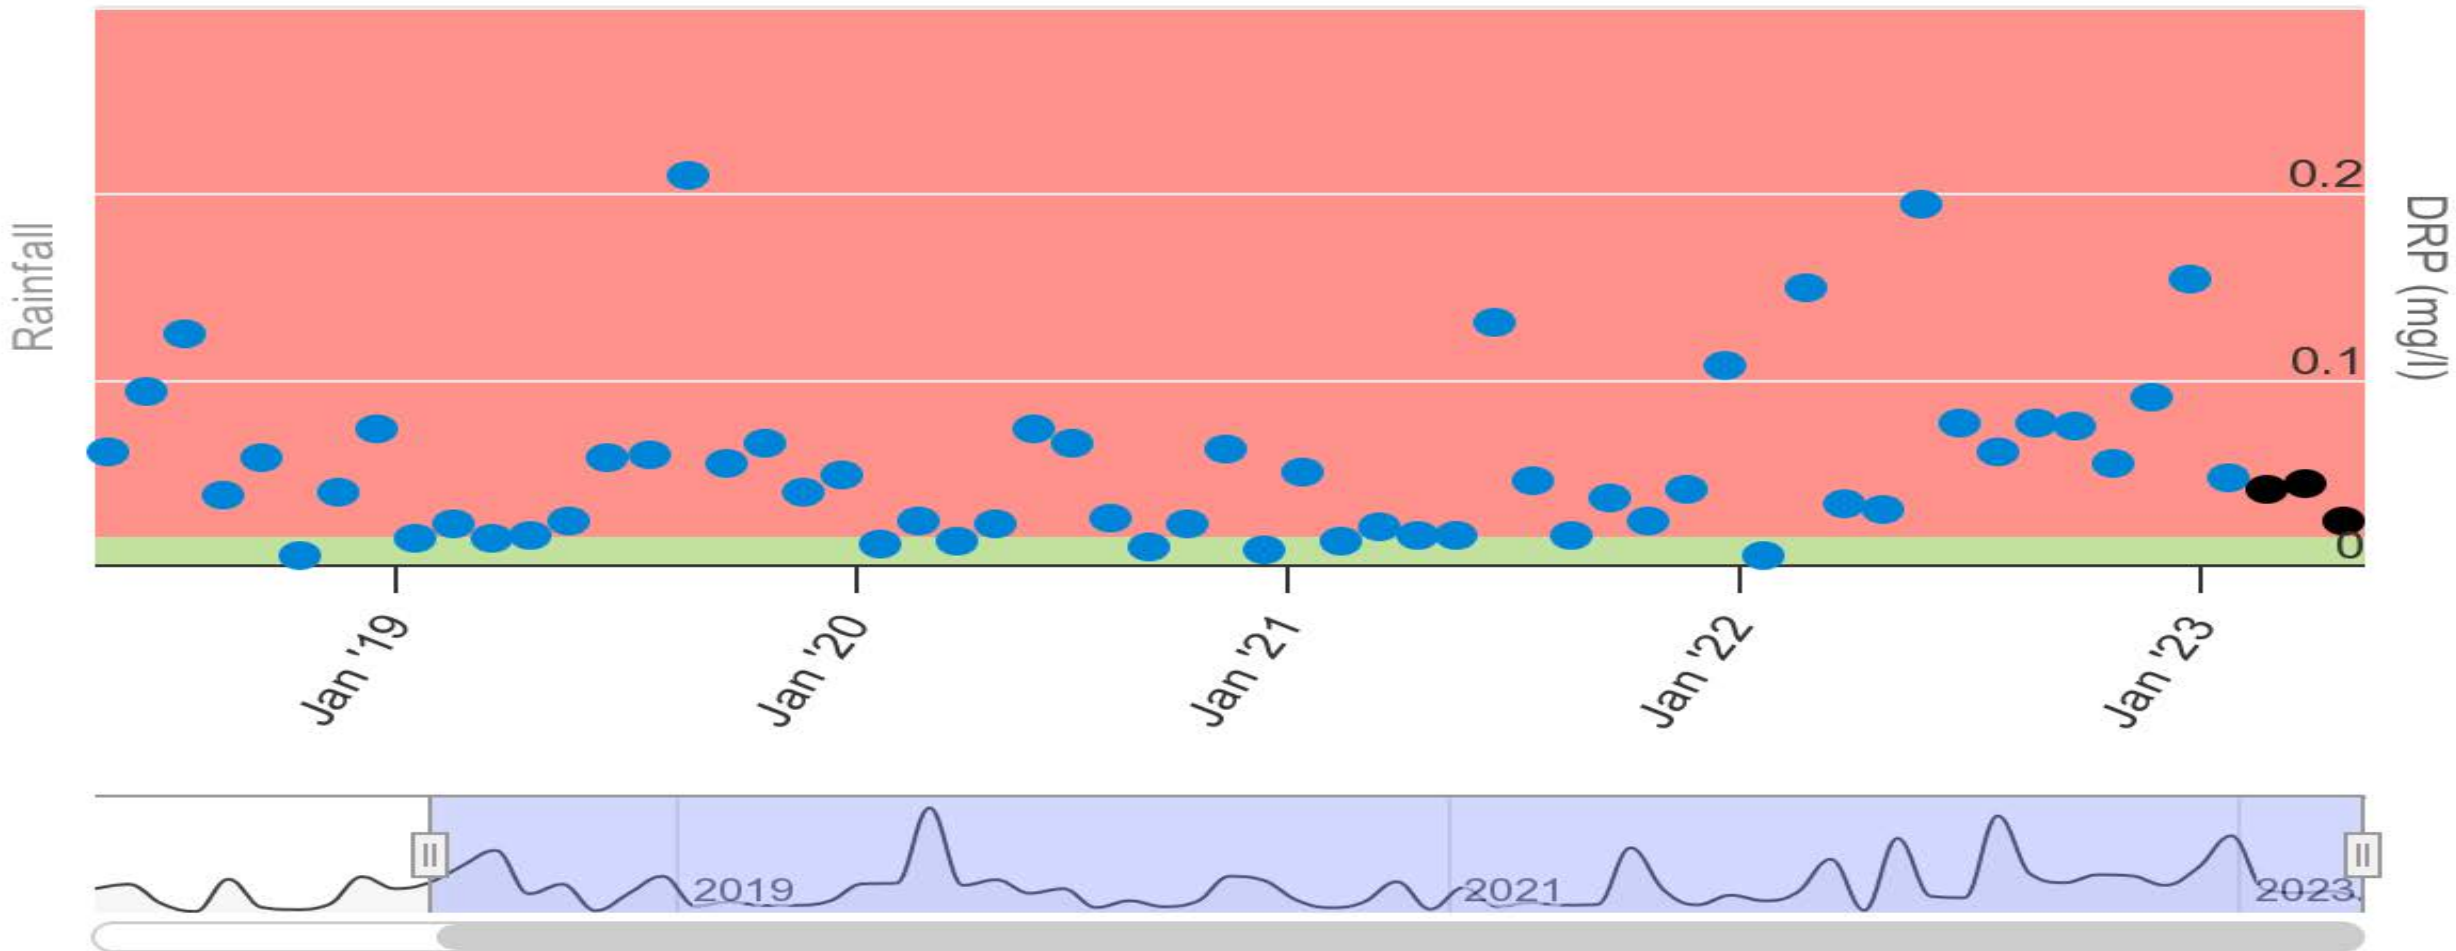
# Phosphorous (DRP) for Maharakeke Stream at State Highway 2 Br

● Maharakeke Stream at State Highway 2 Br ● Rainfall

- ▶ WOWMAP's Survey to landowners in 2021 resulted in an estimated 70% of our required waterways had stock exclusion (they were fenced);
- ▶ Nitrogen tests were reducing
- ▶ Phosphate tests were reducing
- ▶ It wasn't raining - water table levels were extremely low;
- ▶ Then it rained, and rained, and rained.
