FarmAPT to identify targeted water quality mitigation practices at farm-scale

Katrina Macintosh
Christophe Thiange

June 2024

FarmAPT – support uptake of actions

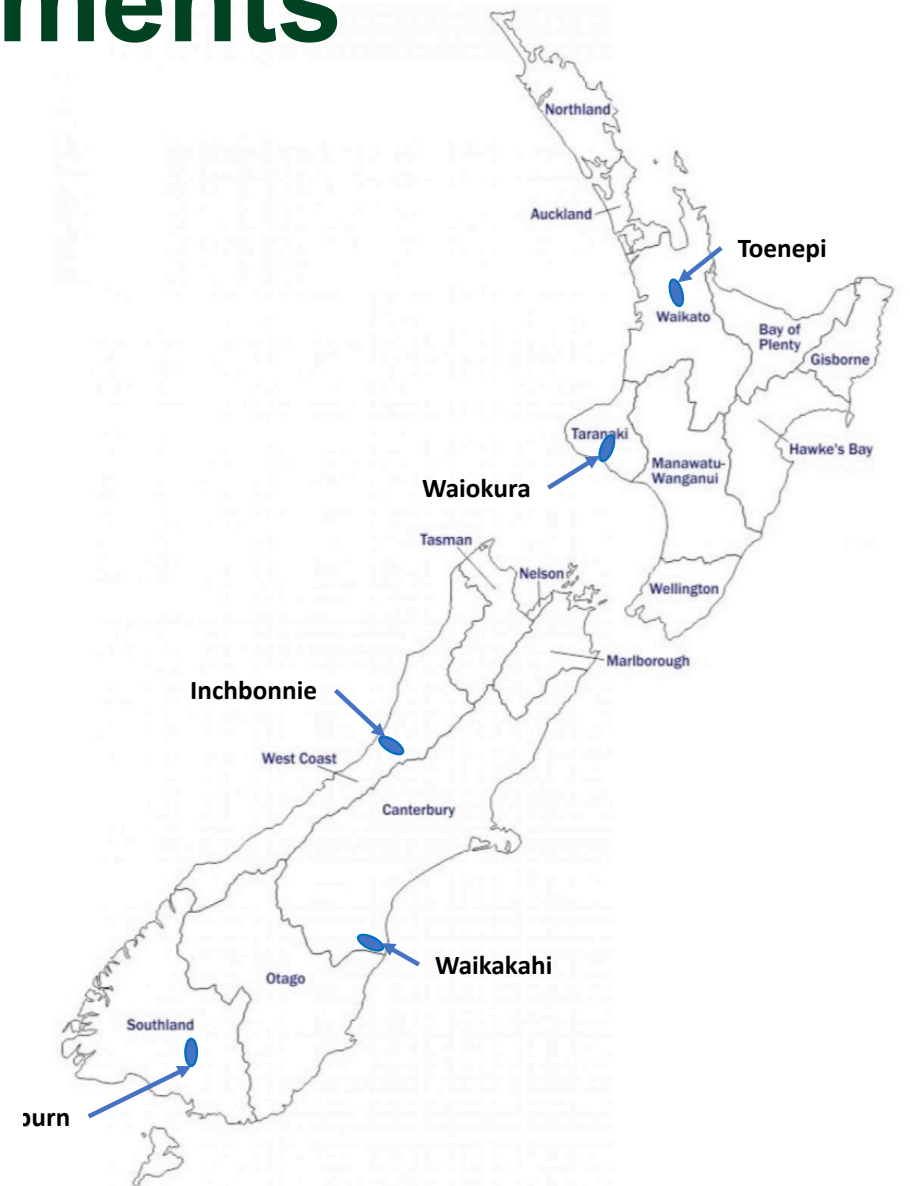
Green = improving trend (in-stream concentration has decreased)
Red = degrading trend (in-stream concentration has increased)

Number of catchments with improving (green) and degrading (red) water quality trends across the five catchments during the 20-year study period, 2001 to 2020.
(Note: Toenepi showed no change for suspended sediments).

T	=	Toenepi
Wo	=	Waiokura
I	=	Inchbonnie
Wa	=	Waikakah
B	=	Bog Burn

- Two-thirds of in-stream water quality trends were improving
- Some were degrading, especially nitrate-nitrogen

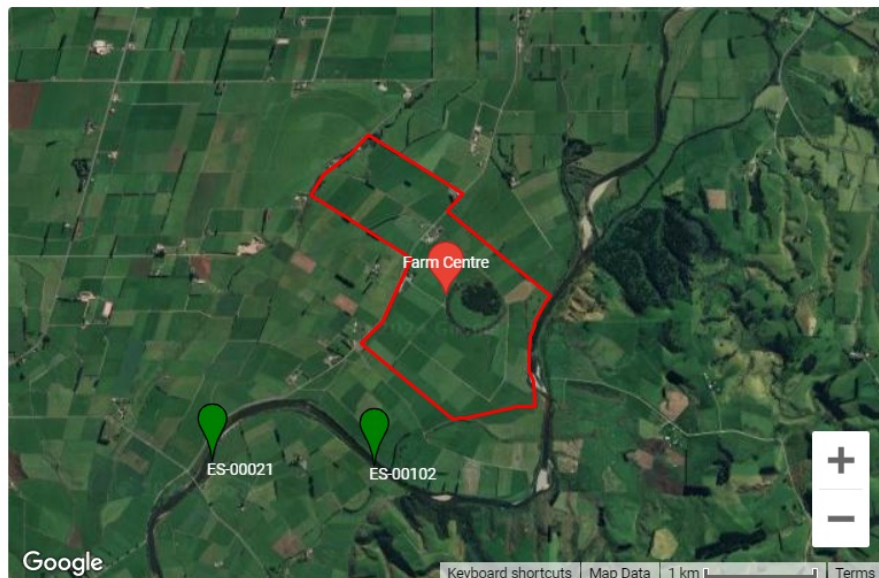
LOCATION

PROPERTY TITLES

ZOOM LEVEL

1km

- Dairy typologies (Monaghan et al., 2021a&b; McDowell et al., 2021)
 - Climate; slope; soil drainage & wetness
- Nearest downstream water quality data
 - LAWA (monitored) & NIWA (modelled) = ***catchment context***
- Comprehensive list of mitigation actions (over 20 yrs. research)
- Rank actions by:
 - ‘*Effectiveness*’ or ‘*Cost-effectiveness*’ (for N, P, sediment & *E. coli*)
 - ‘*Established*’ or ‘*Developing*’ mitigation
 - ‘*Capital*’ cost
- Quick link(s) to implementation resources

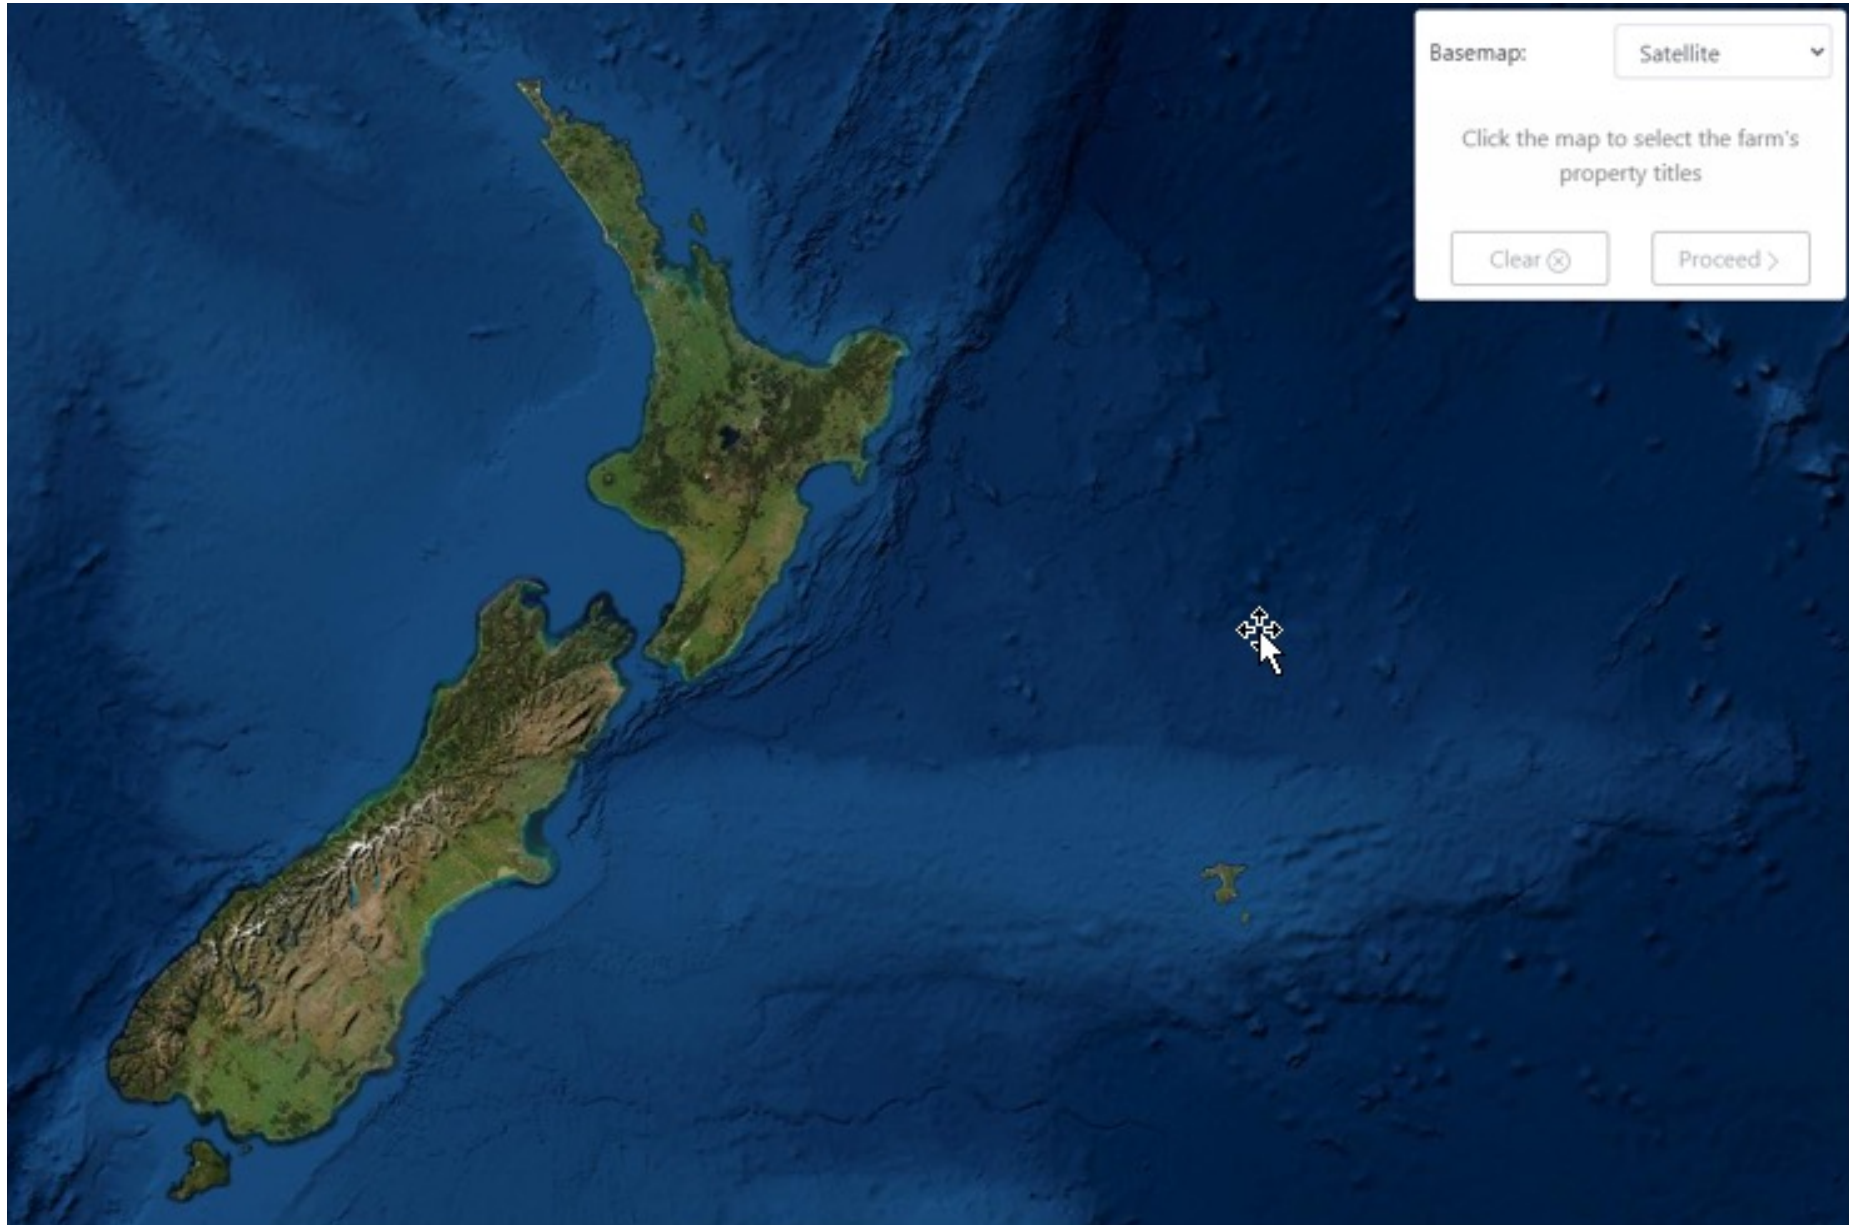
Location

Property titles

1. 214068
2. 97213

Typology

Climate:	Cool	Warm		
Soil:	Light	Well draining	Poorly draining	
Slope:	Flat	Rolling		
Wetness:	Dry	Moist	Wet	Irrigated

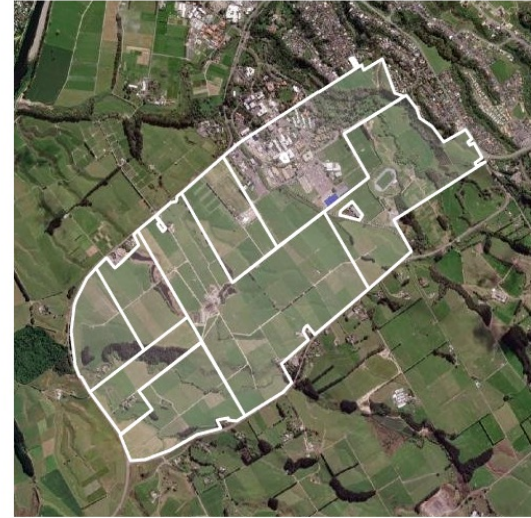
Typology

- Climate: Cool Warm
- Soil: Light Well draining Poorly draining
- Slope: Flat Rolling
- Wetness: Dry Moist Wet Irrigated

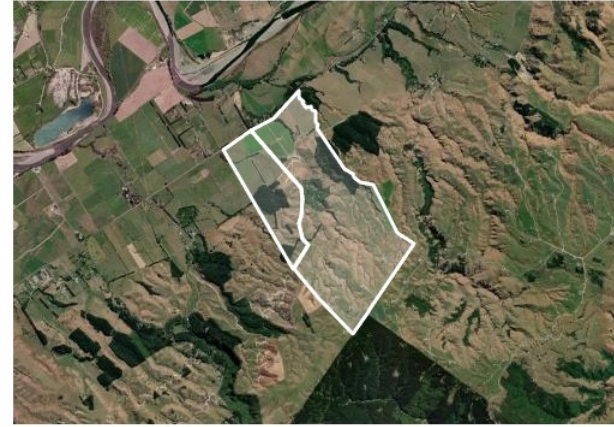
Typology

Climate:	Cool	Warm		
Soil:	Light	Well draining	Poorly draining	
Slope:	Flat	Rolling		
Wetness:	Dry	Moist	Wet	Irrigated

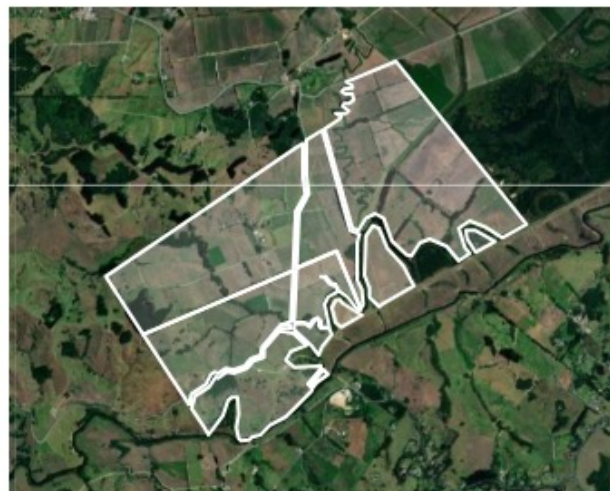
Typology

Climate:	Cool	Warm		
Soil:	Light	Well draining	Poorly draining	
Slope:	Flat	Rolling		
Wetness:	Dry	Moist	Wet	Irrigated
