# Use of Native Sedges to Reduce Cow Cress

TIAKI WAI | CARING FOR LAND & WATER

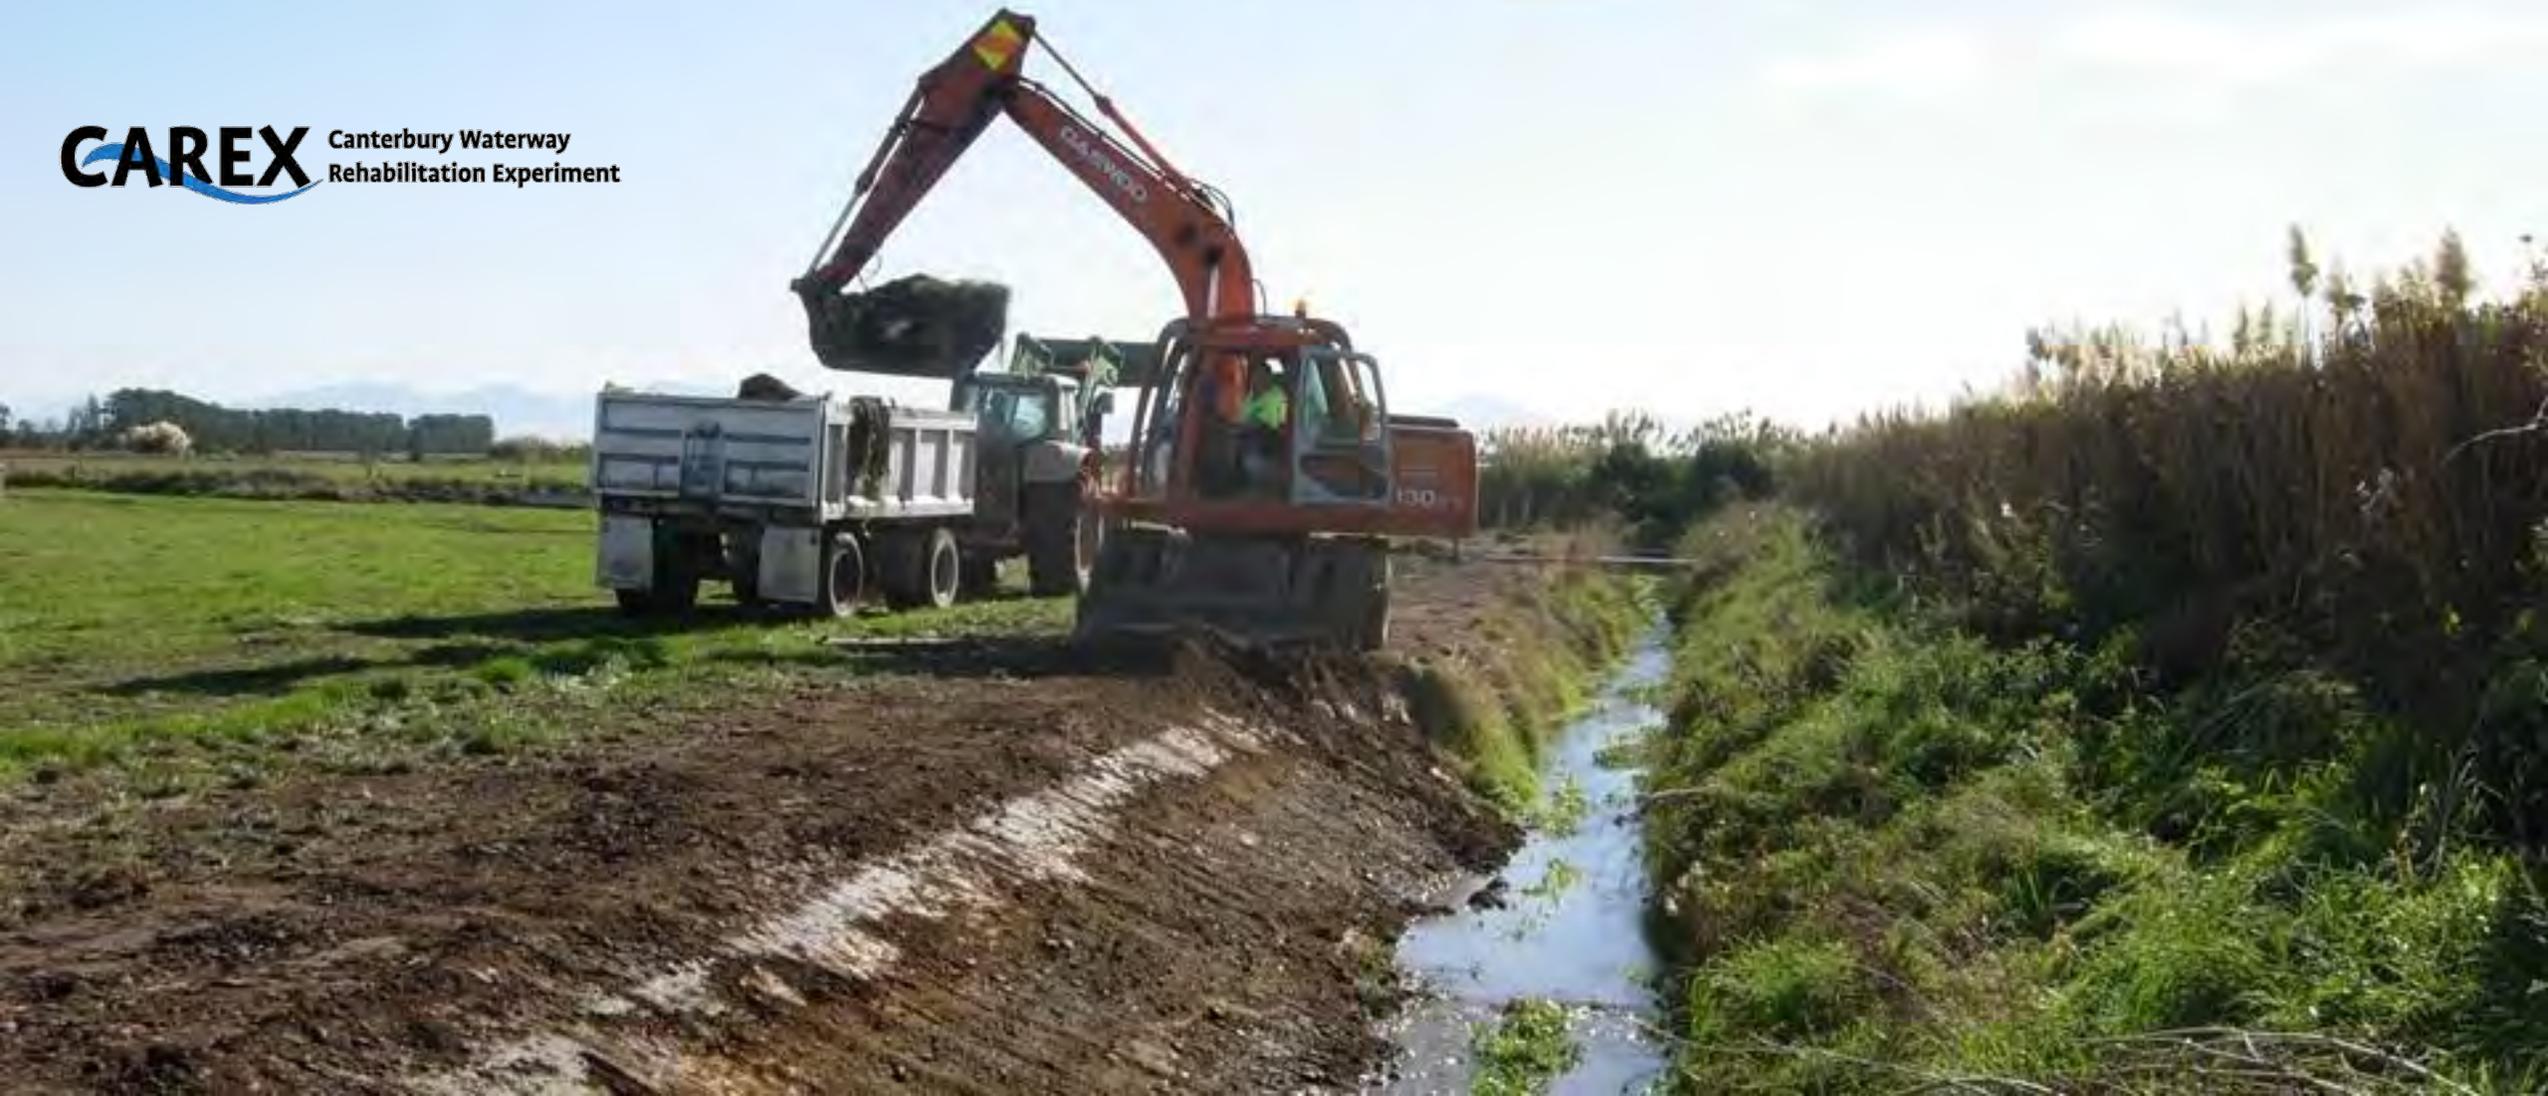
*Carex secta* along the water's edge stop nuisance weeds from establishing.

No drain maintenance has been required 3+ years since planting.

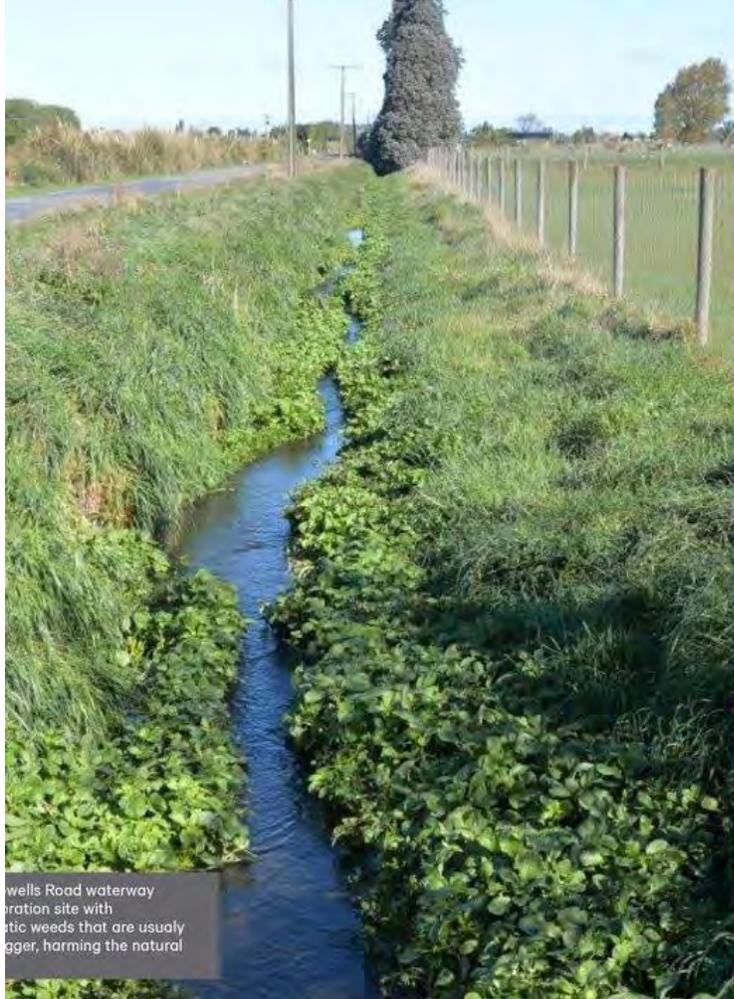
Powells Road waterway  
restoration site with  
aquatic weeds that are usually  
tougher, harming the natural

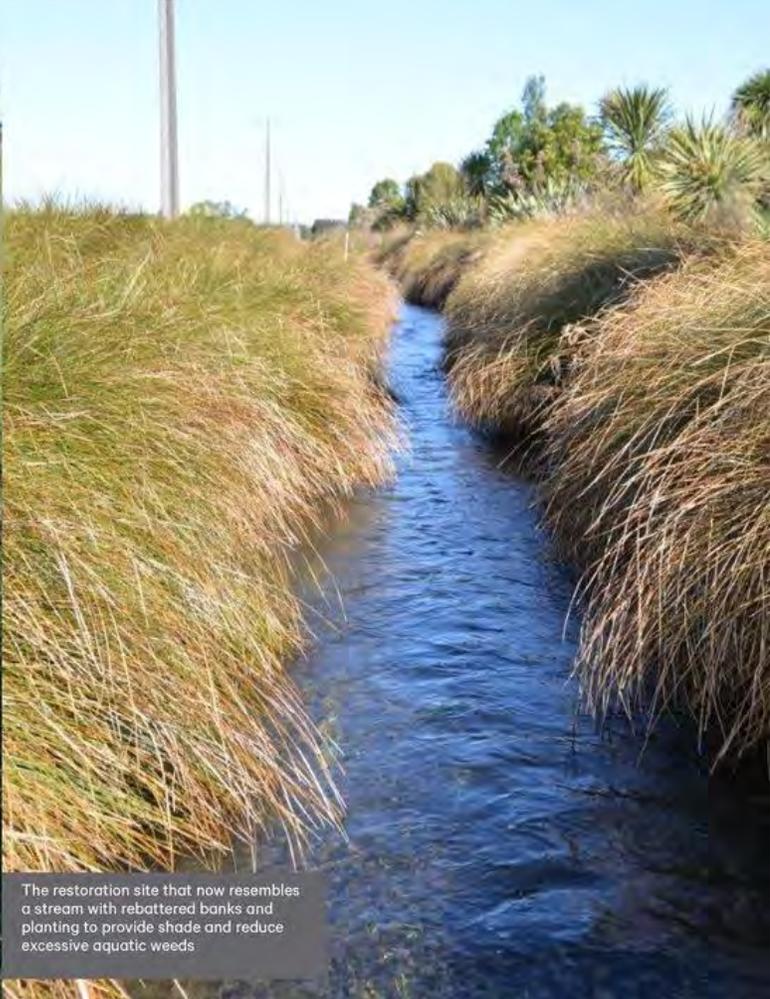
The restoration site that now resembles  
a stream with rebattered banks and  
planting to provide shade and reduce  
excessive aquatic weeds

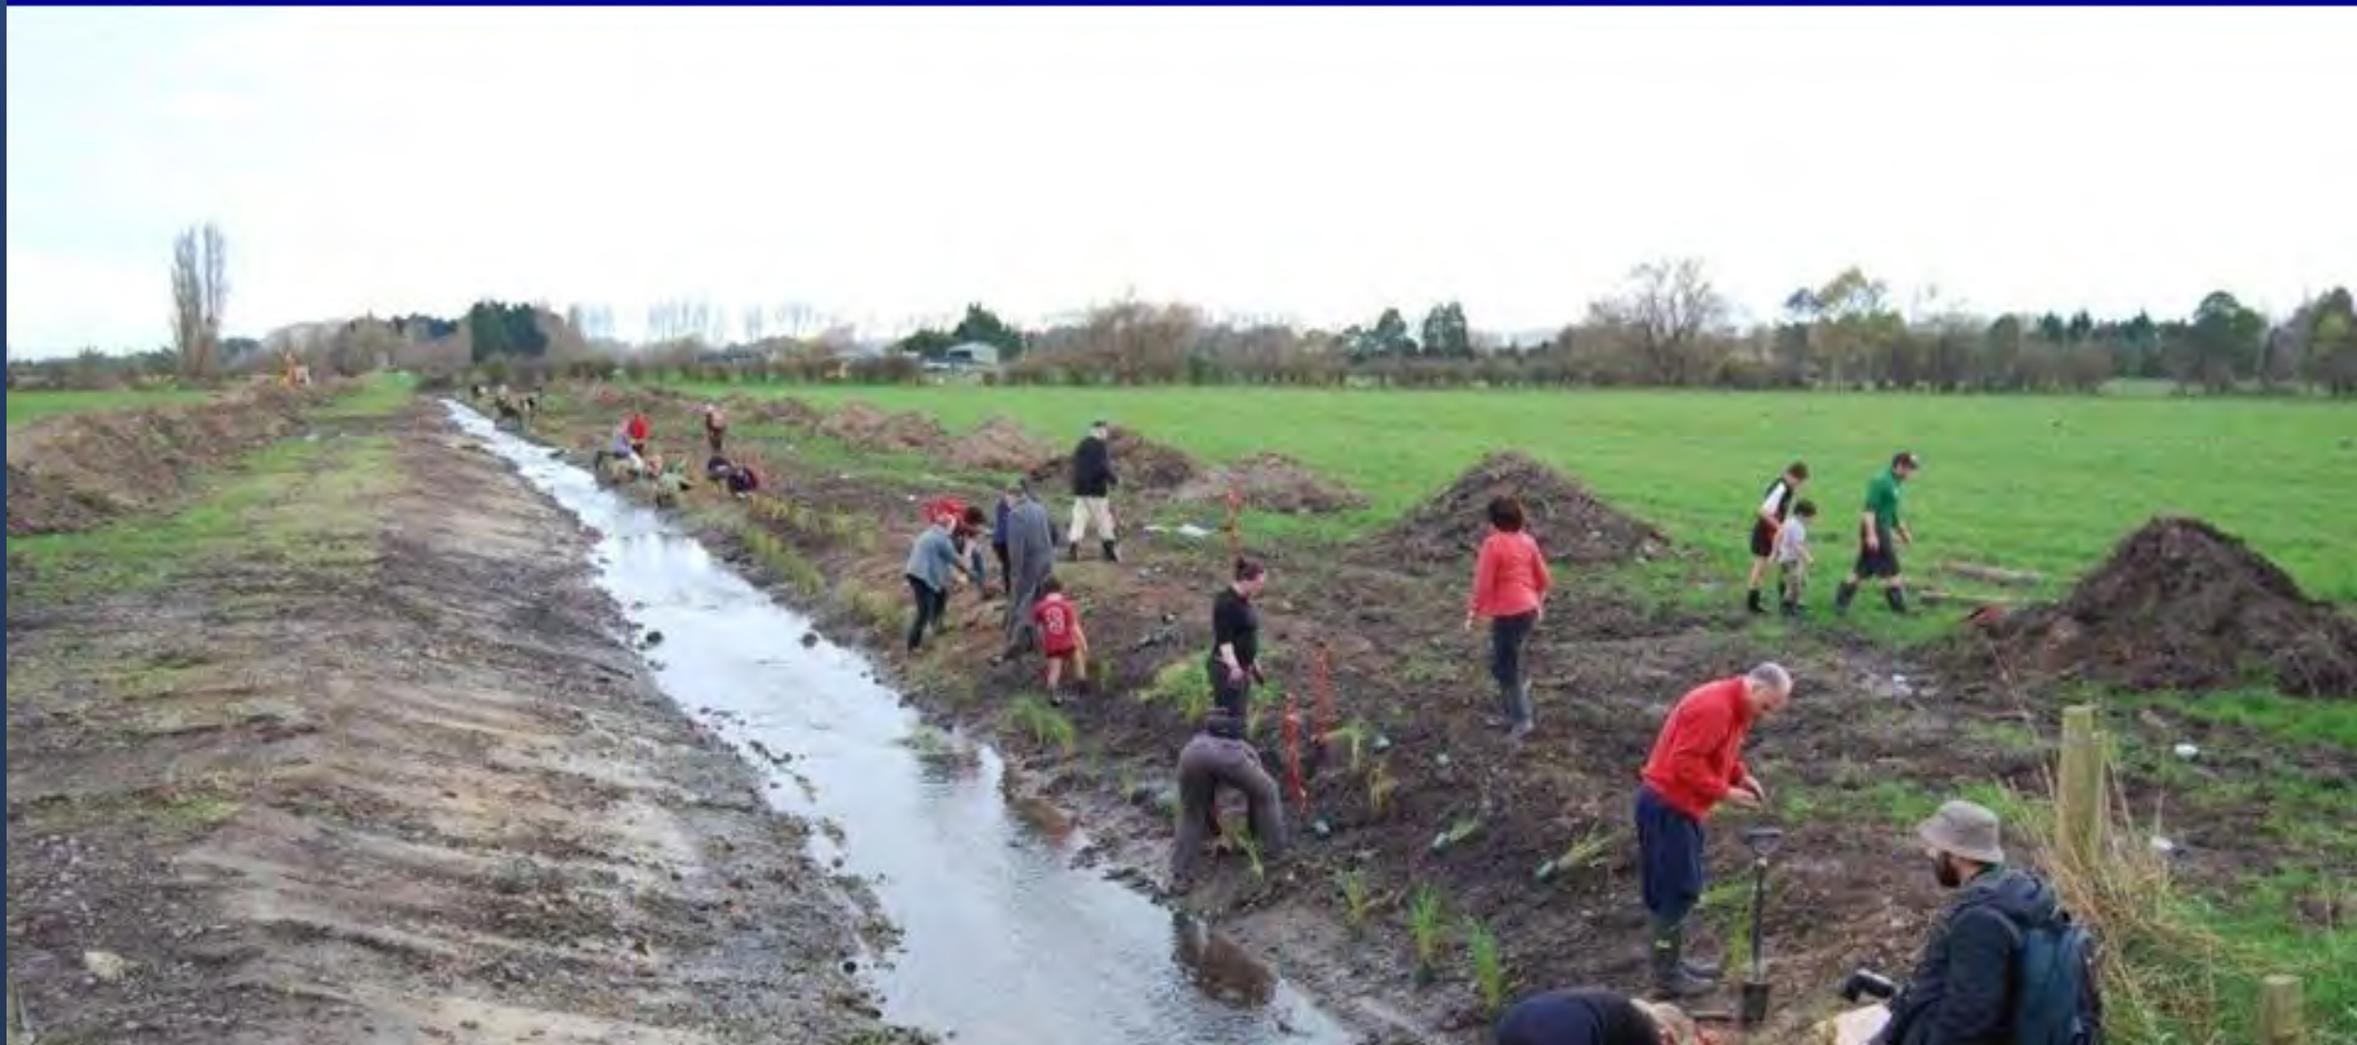
## Widened riparian on one side – planting on North side
